Case study: CS002

Bioremediation of Railadevi Lake in Thane City, Maharashtra

The Railadevi lake bioremediation project was funded by Ministry of Environment and Forest (MoEF), Government of India.

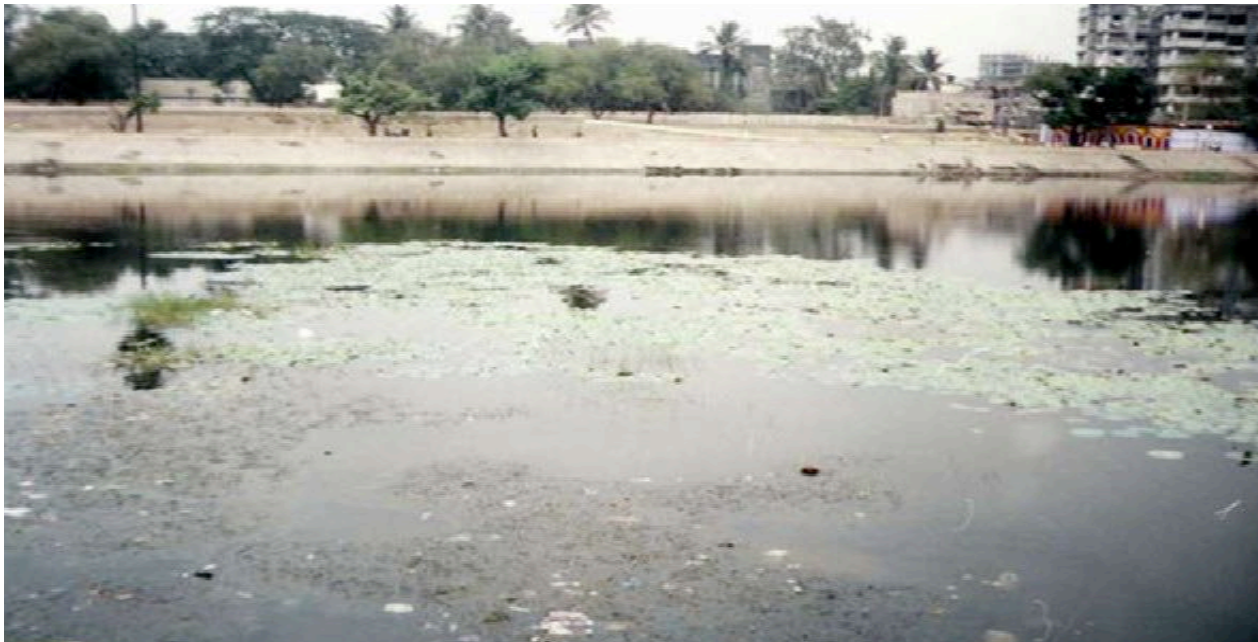
Fig 2: Condition of Lake Railadevi – year 2003

The project was undertaken in the mid of year 2003. The lake was in eutrophic conditions, before starting the remediation process. Due to heavy onslaught of manmade pollution the lake had turned eutrophic. Algal blooms were yearly affair and heavy sludge deposits had blocked the natural springs

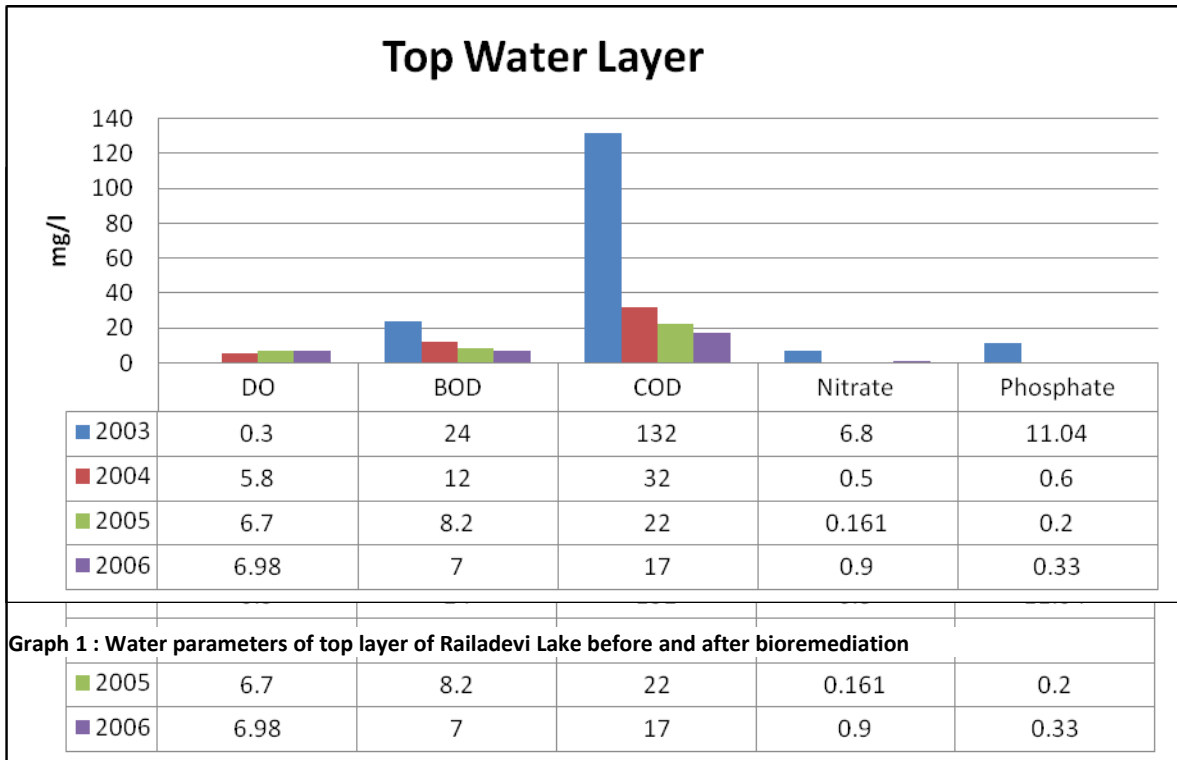
After bioremediation of the lake, most of the water quality parameters like COD, BOD, Nitrogen & Phosphate showed declining trend. The overall visual appearance was improved significantly and water quality was found to be very good.

Graph 2 : Water parameters of bottom layer of Railadevi Lake before and after bioremediation

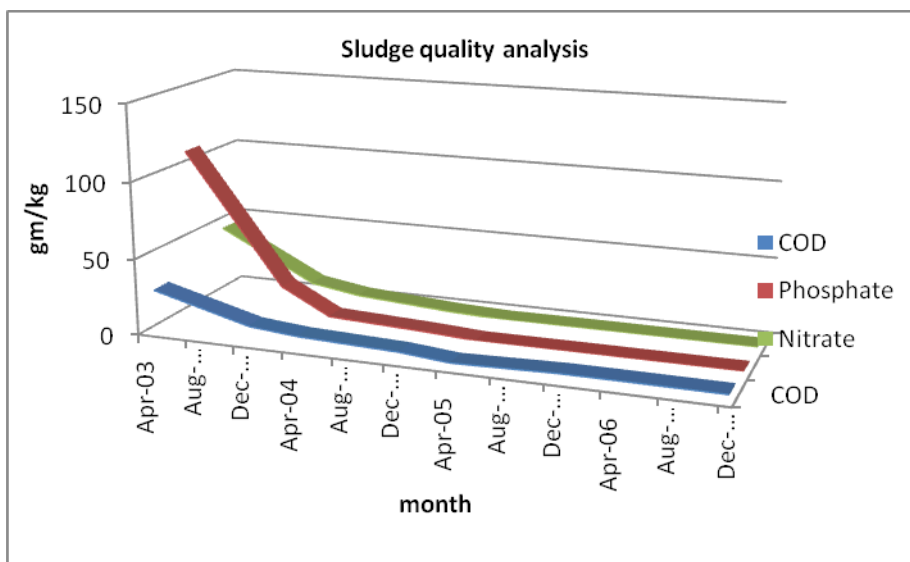
Graph 3: Sludge quality analysis of Railadevi Lake before and after bioremediation

Parameter	Unit	April 03	Dec 03	April 04	Dec 04	April 05	Dec 05	April 06	April 06
COD	gm/kg	~35	~15	~10	~5	~3	~2	~1	~1
Phosphate	gm/kg	~120	~40	~20	~10	~5	~3	~2	~1
Nitrate	gm/kg	~70	~30	~15	~8	~4	~2	~1	~1

COD	gm/kg	26	9	6.1	3.8	0.8	2.4	2.4	2.1
Phosphate	gm/kg	108	22	5	2.08	0.064	0.145	0.122	0.112
Nitrate	gm/kg	44	11	5.8	1.32	0.084	0.217	0.134	0.124

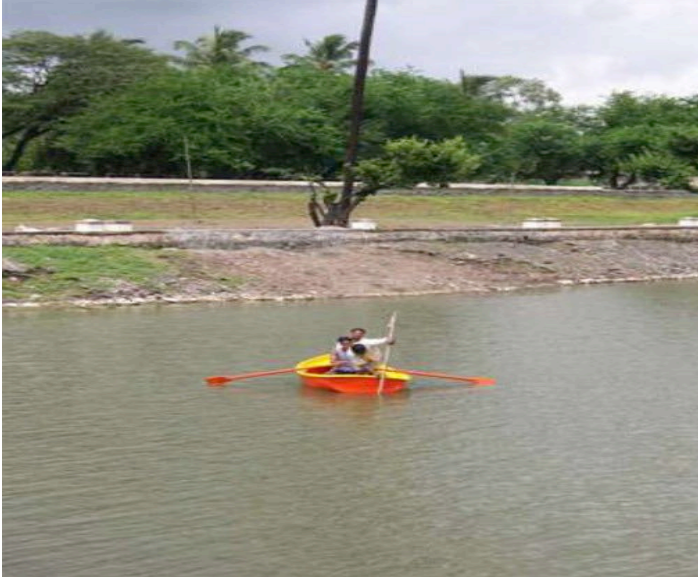
Fig 1: Lake Condition after bioremediation project
